**Flood Control Project Maintenance
Levee Inspections**
LMA District Cover Sheet
Spring 2009 Levee Inspection Results

Reclamation District No. 0900

Levee Inspection Report By Mile - Spring 2009

Waterway	Bank	Unit Miles	Inspection Start/End	Inspector
Unit No. 01 Sacramento River	Right	7.90	04/16/2009 04/16/2009	David Pesavento

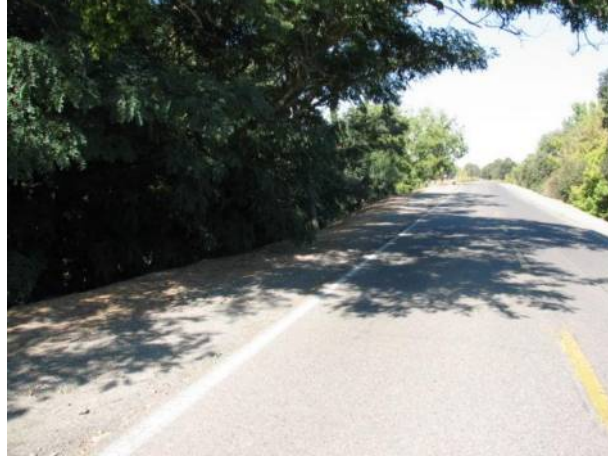
Levee Mile Report Line	14
Start Levee Mile	2.56
End Levee Mile	2.64
Location	Land Side
Category	Earthen Levee
Item	Trim / Thin Trees
Trim trees to 5' from surface of levee on landside slope from LM 2.56 to LM 2.64

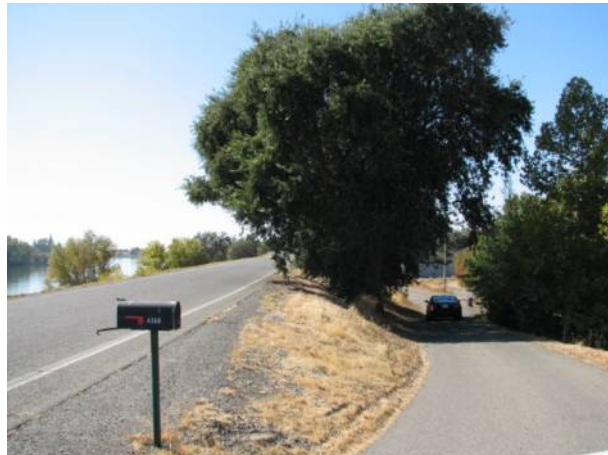
Levee Mile Report Line	48
Start Levee Mile	6.25
End Levee Mile	6.28
Location	Land Side
Category	Earthen Levee
Item	Trim / Thin Trees
Trim trees to 5 feet from levee surface LM 6.25-6.28

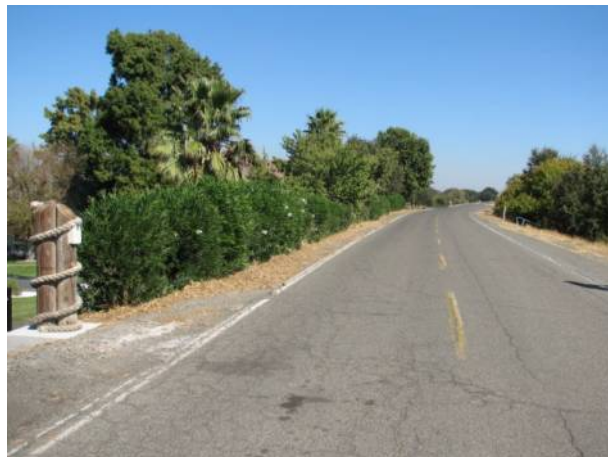
Levee Mile Report Line	51
Start Levee Mile	6.56
End Levee Mile	6.63
Location	Land Side
Category	Earthen Levee
Item	Encroachments
Landscape encroachment at LM 6.56 to LM 6.63

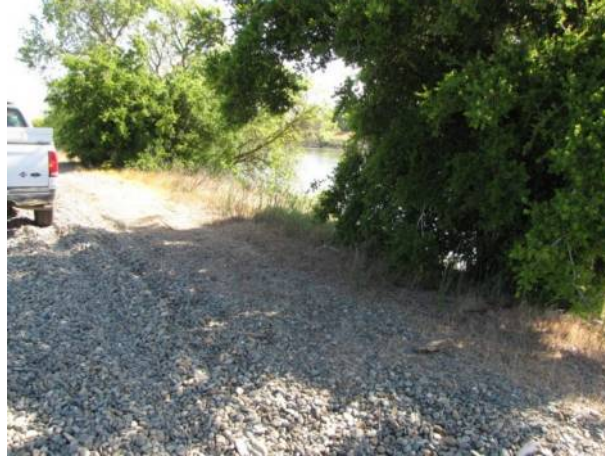
Levee Mile Report Line	73
Start Levee Mile	7.44
End Levee Mile	7.44
Location	Water Side
Category	Earthen Levee
Item	Trim / Thin Trees

Trim trees to allow for visibility and ability to flood fight at LM 7.44.

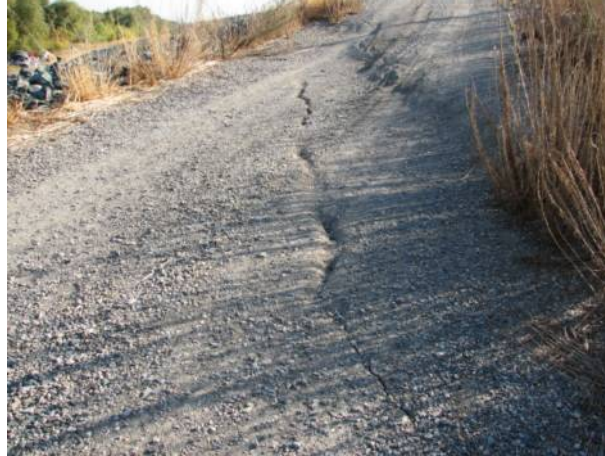
Levee Mile Report Line	4
Start Levee Mile	0.95
End Levee Mile	0.95
Location	Water Side
Category	Earthen Levee
Item	Cracking
Crack located on ramp on waterside of levee at LM 0.95.

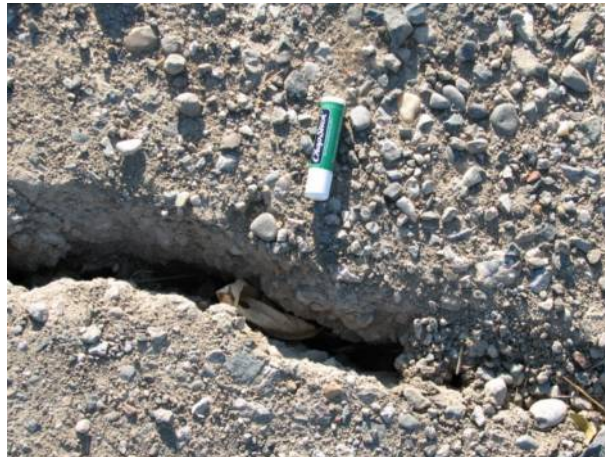
Levee Mile Report Line	4
Start Levee Mile	0.95
End Levee Mile	0.95
Location	Water Side
Category	Earthen Levee
Item	Cracking
Closer view of crack at LM 0.95.

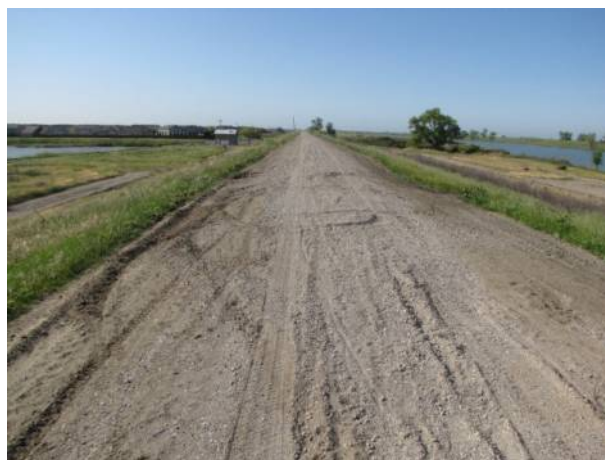
Levee Mile Report Line	11
Start Levee Mile	3.10
End Levee Mile	3.10
Location	Crown
Category	Earthen Levee
Item	Crown Surface / Depressions / Rutting
Example of repair done on crown of levee. Depressions in the crown have been repaired and gravel has been placed.
